AERIAL PHOTOGRAPHIC ANALYSIS OF THE GENERAL ELECTRIC-SPOKANE APPARATUS FACILITY Spokane, Washington

TS-PIC-89733

AERIAL PHOTOGRAPHIC ANALYSIS OF THE GENERAL
ELECTRIC-SPOKANE APPARATUS FACILITY

Spokane, Washington

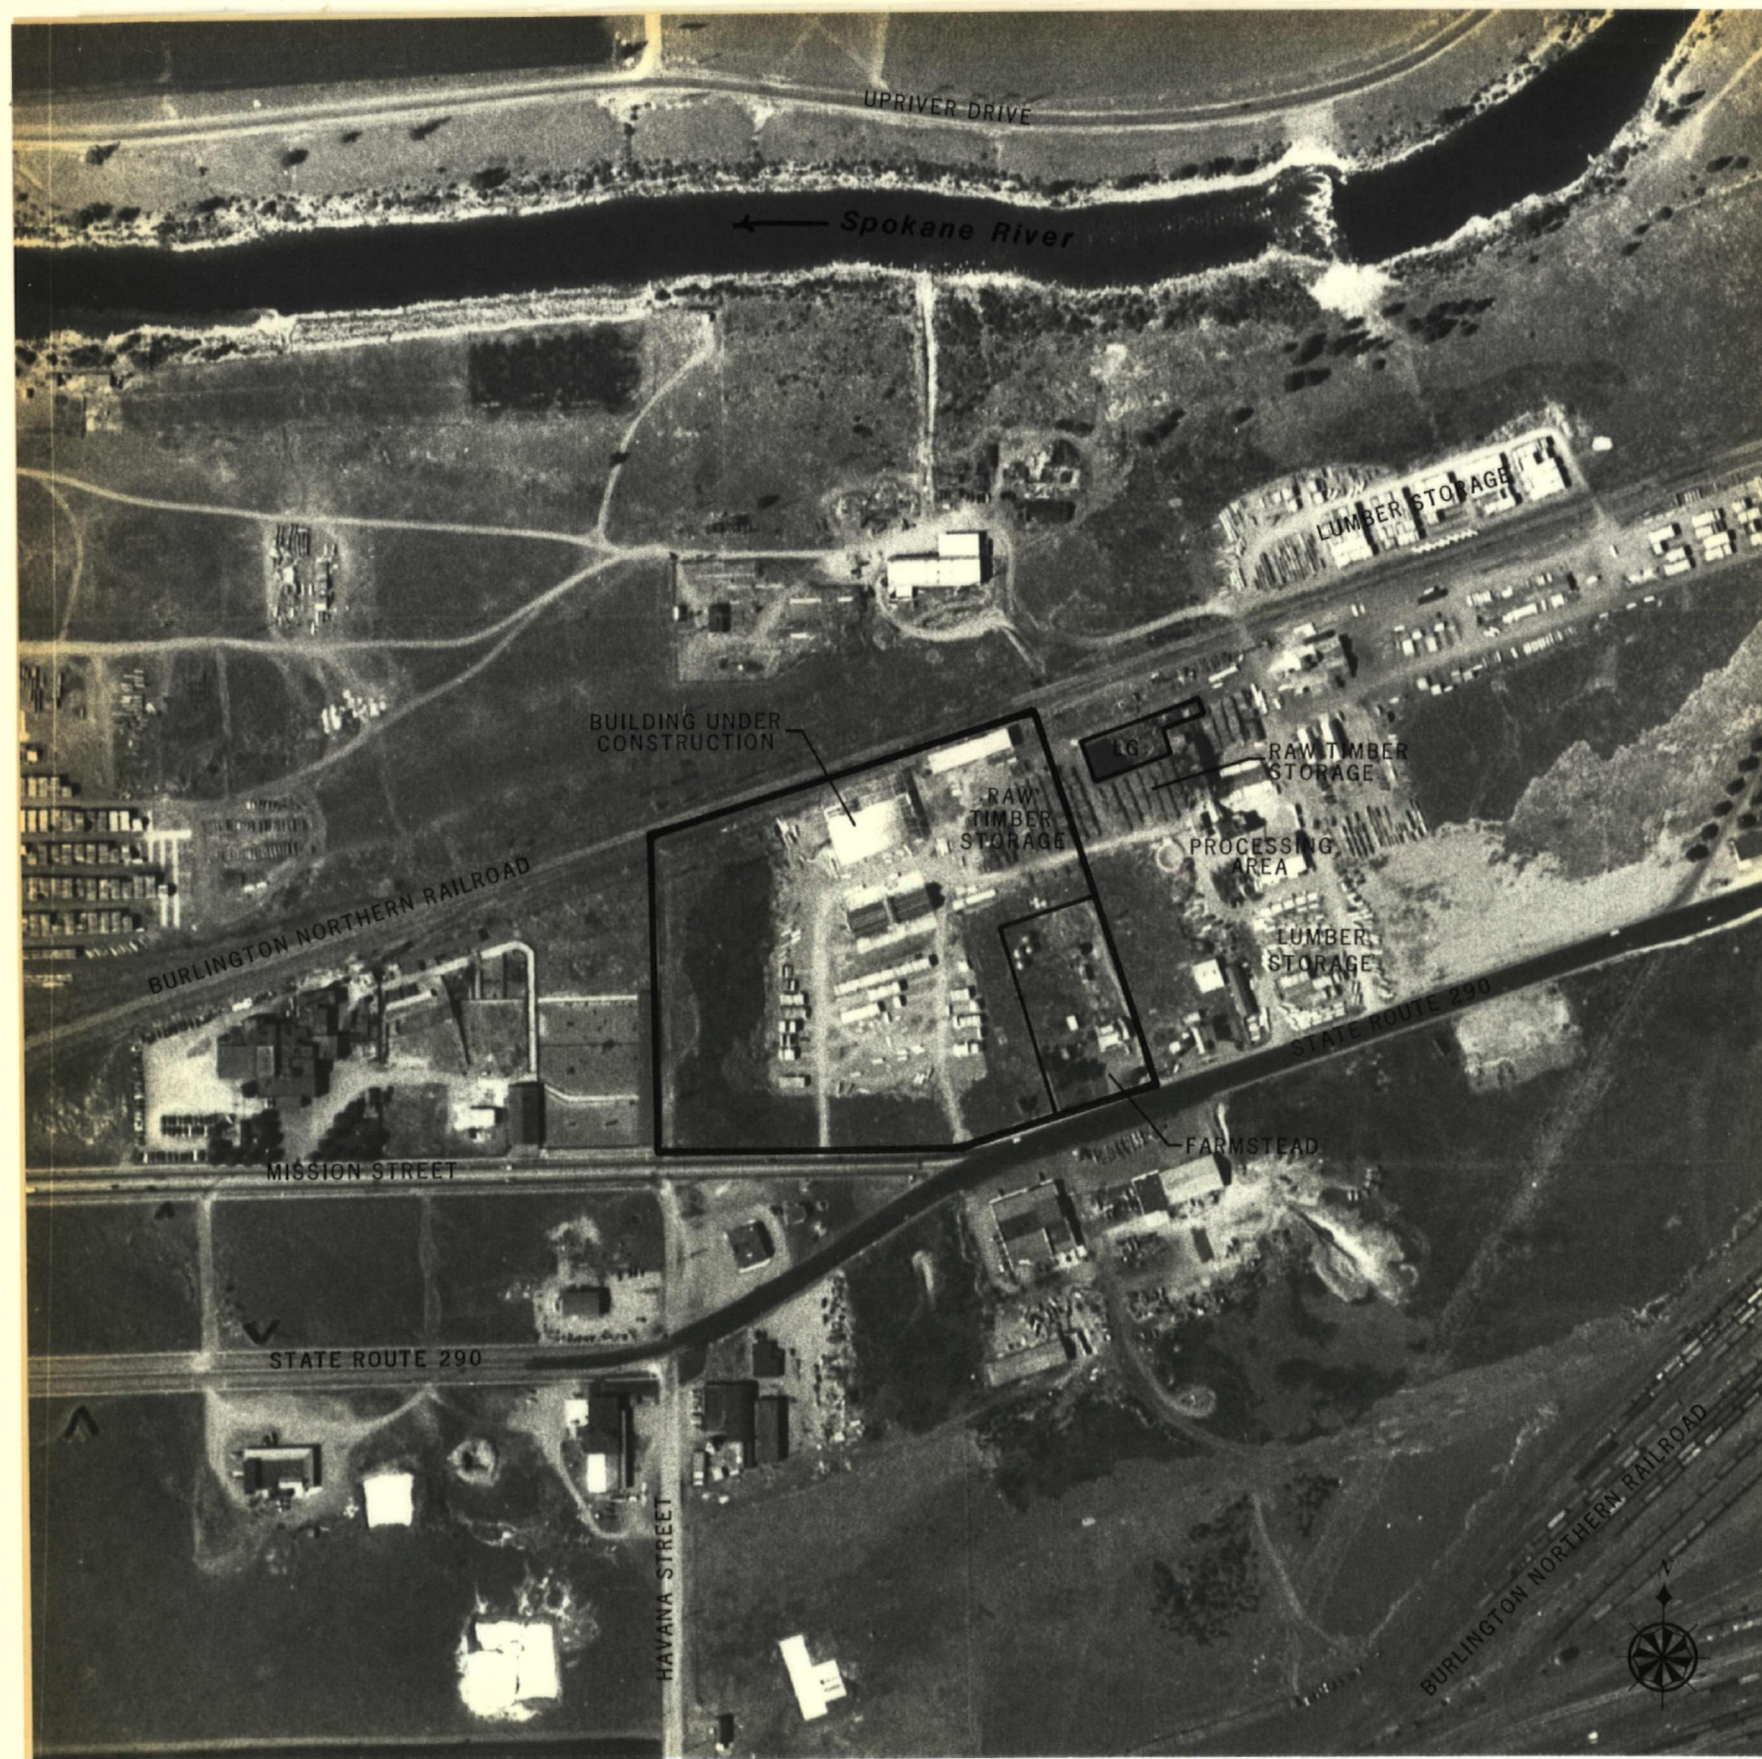
Figure 4. General Electric-Spokane Apparatus facility, July 19, 1951. Approximate scale 1:3,975.

JULY 19, 1951 (FIGURE 4)

A fully operational lumber mill occupies the site and the adjacent parcel of land to the east. Lumber is stored in various areas throughout the site and on the north side of the railroad. A large building is under construction near the railroad. A lagoon and mill is visible to the east. No evidence of a creosote operation exists.

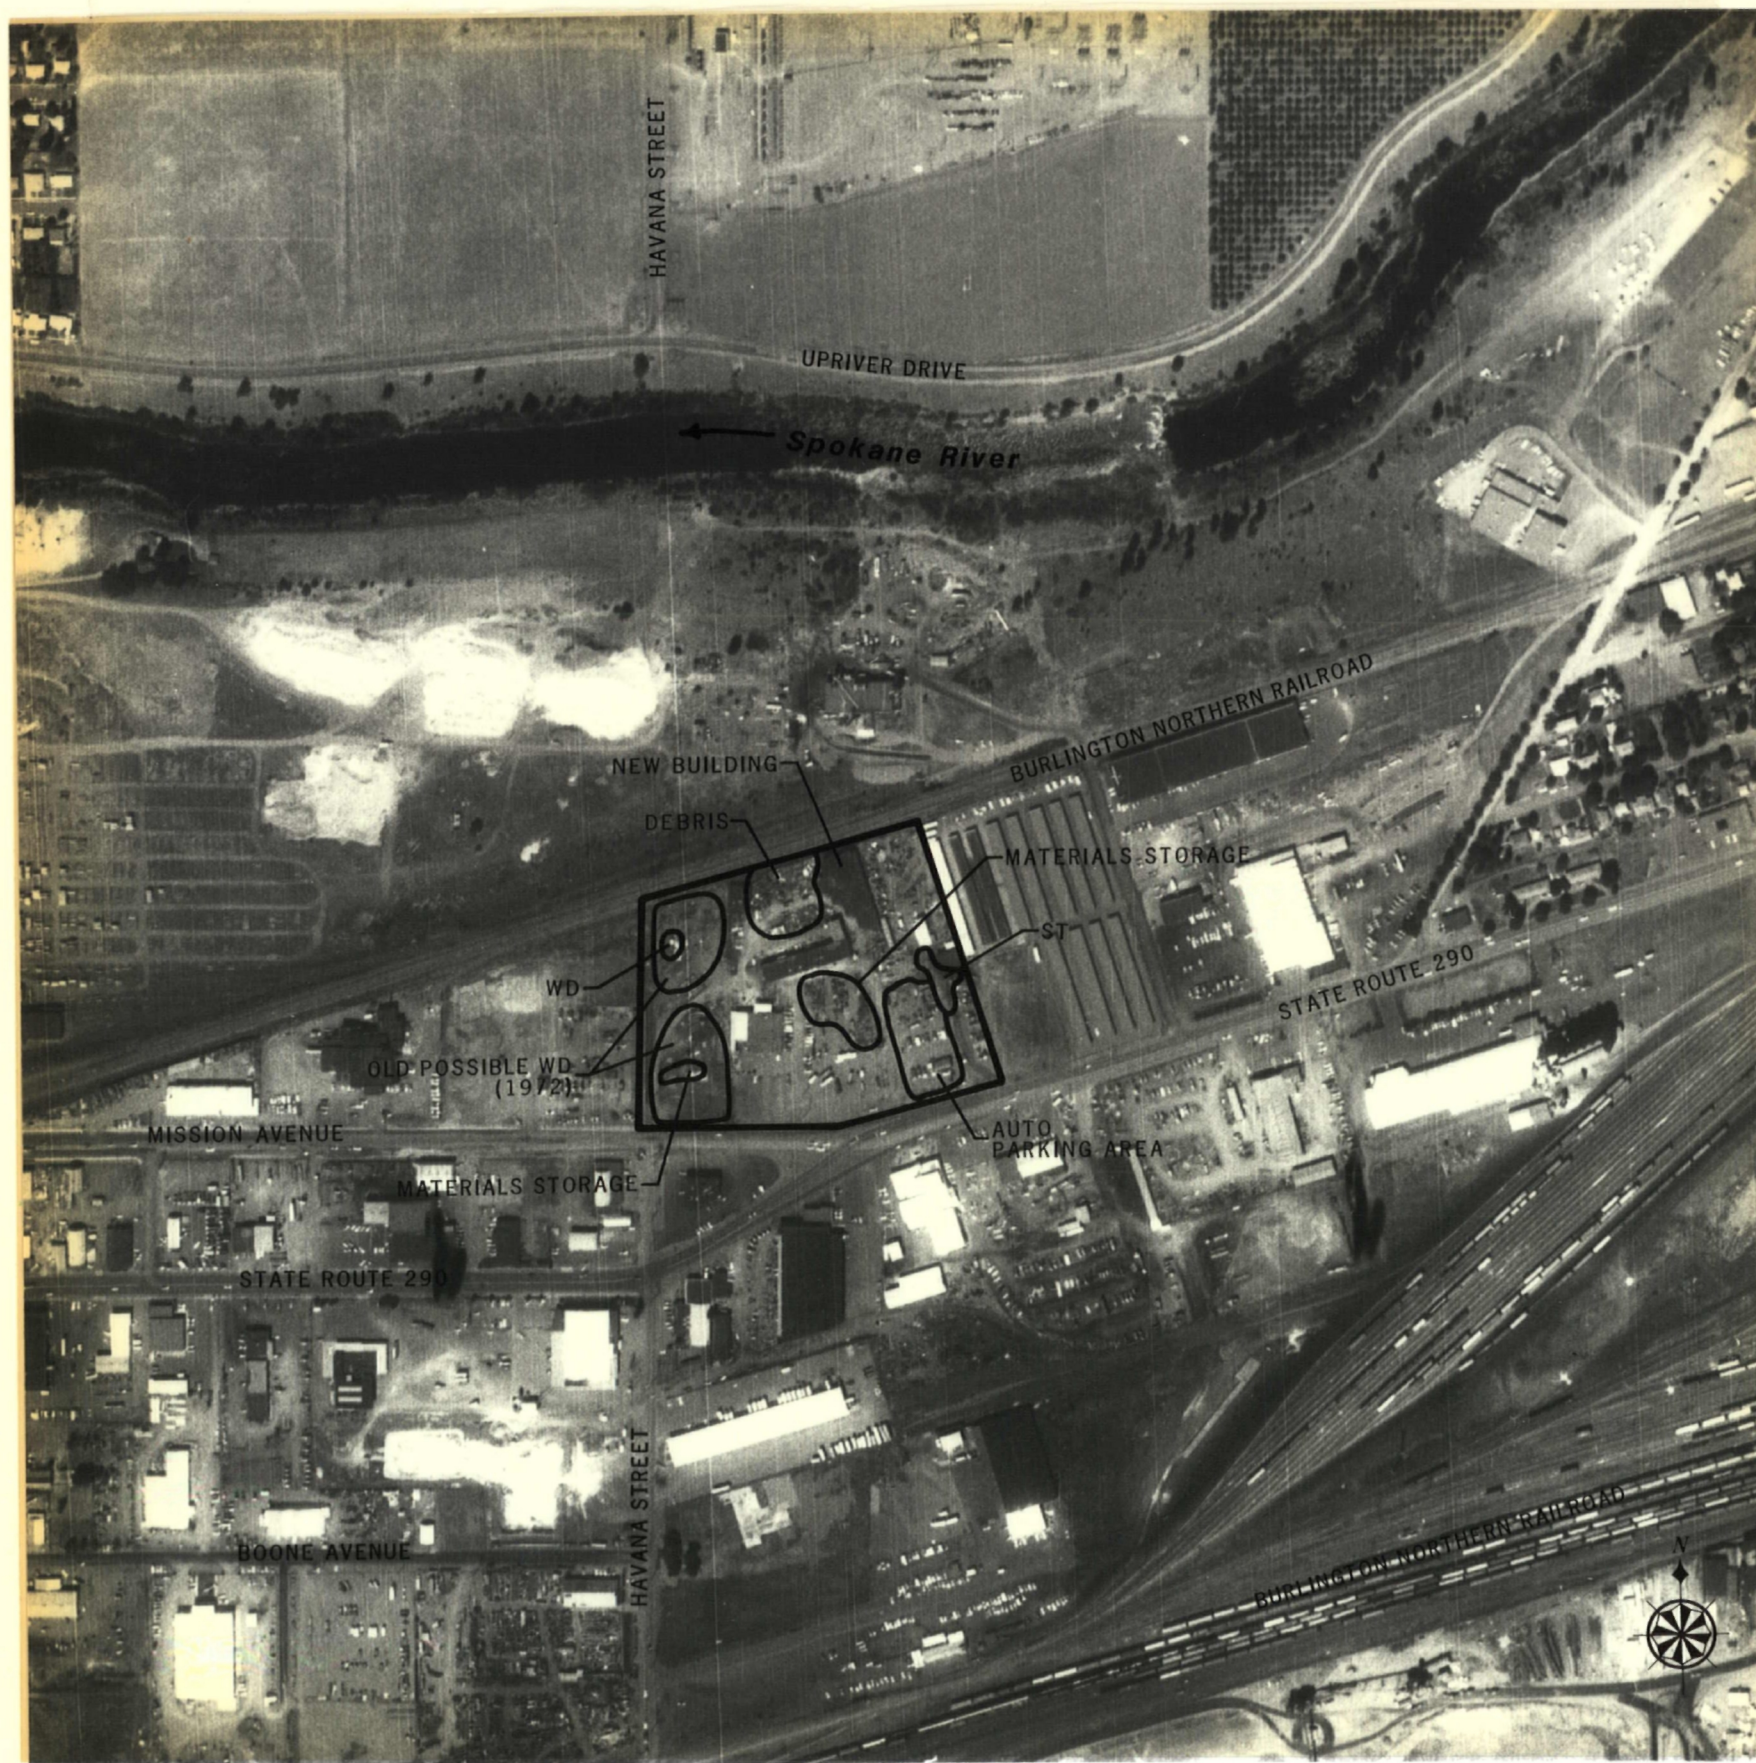
Figure 8. General Electric-Spokane Apparatus facility, July 15, 1977. Approximate scale 1:5,610.

JULY 15, 1977 (FIGURE 8)

A new building is visible in the northern portion of the site. Debris is still located to the west. A stain is located on the eastern periphery of the site. The two possible waste disposal areas seen in 1972 are still visible. Two smaller areas of waste disposal and materials storage are visible at the same areas. A set of storage buildings has been constructed to the east.

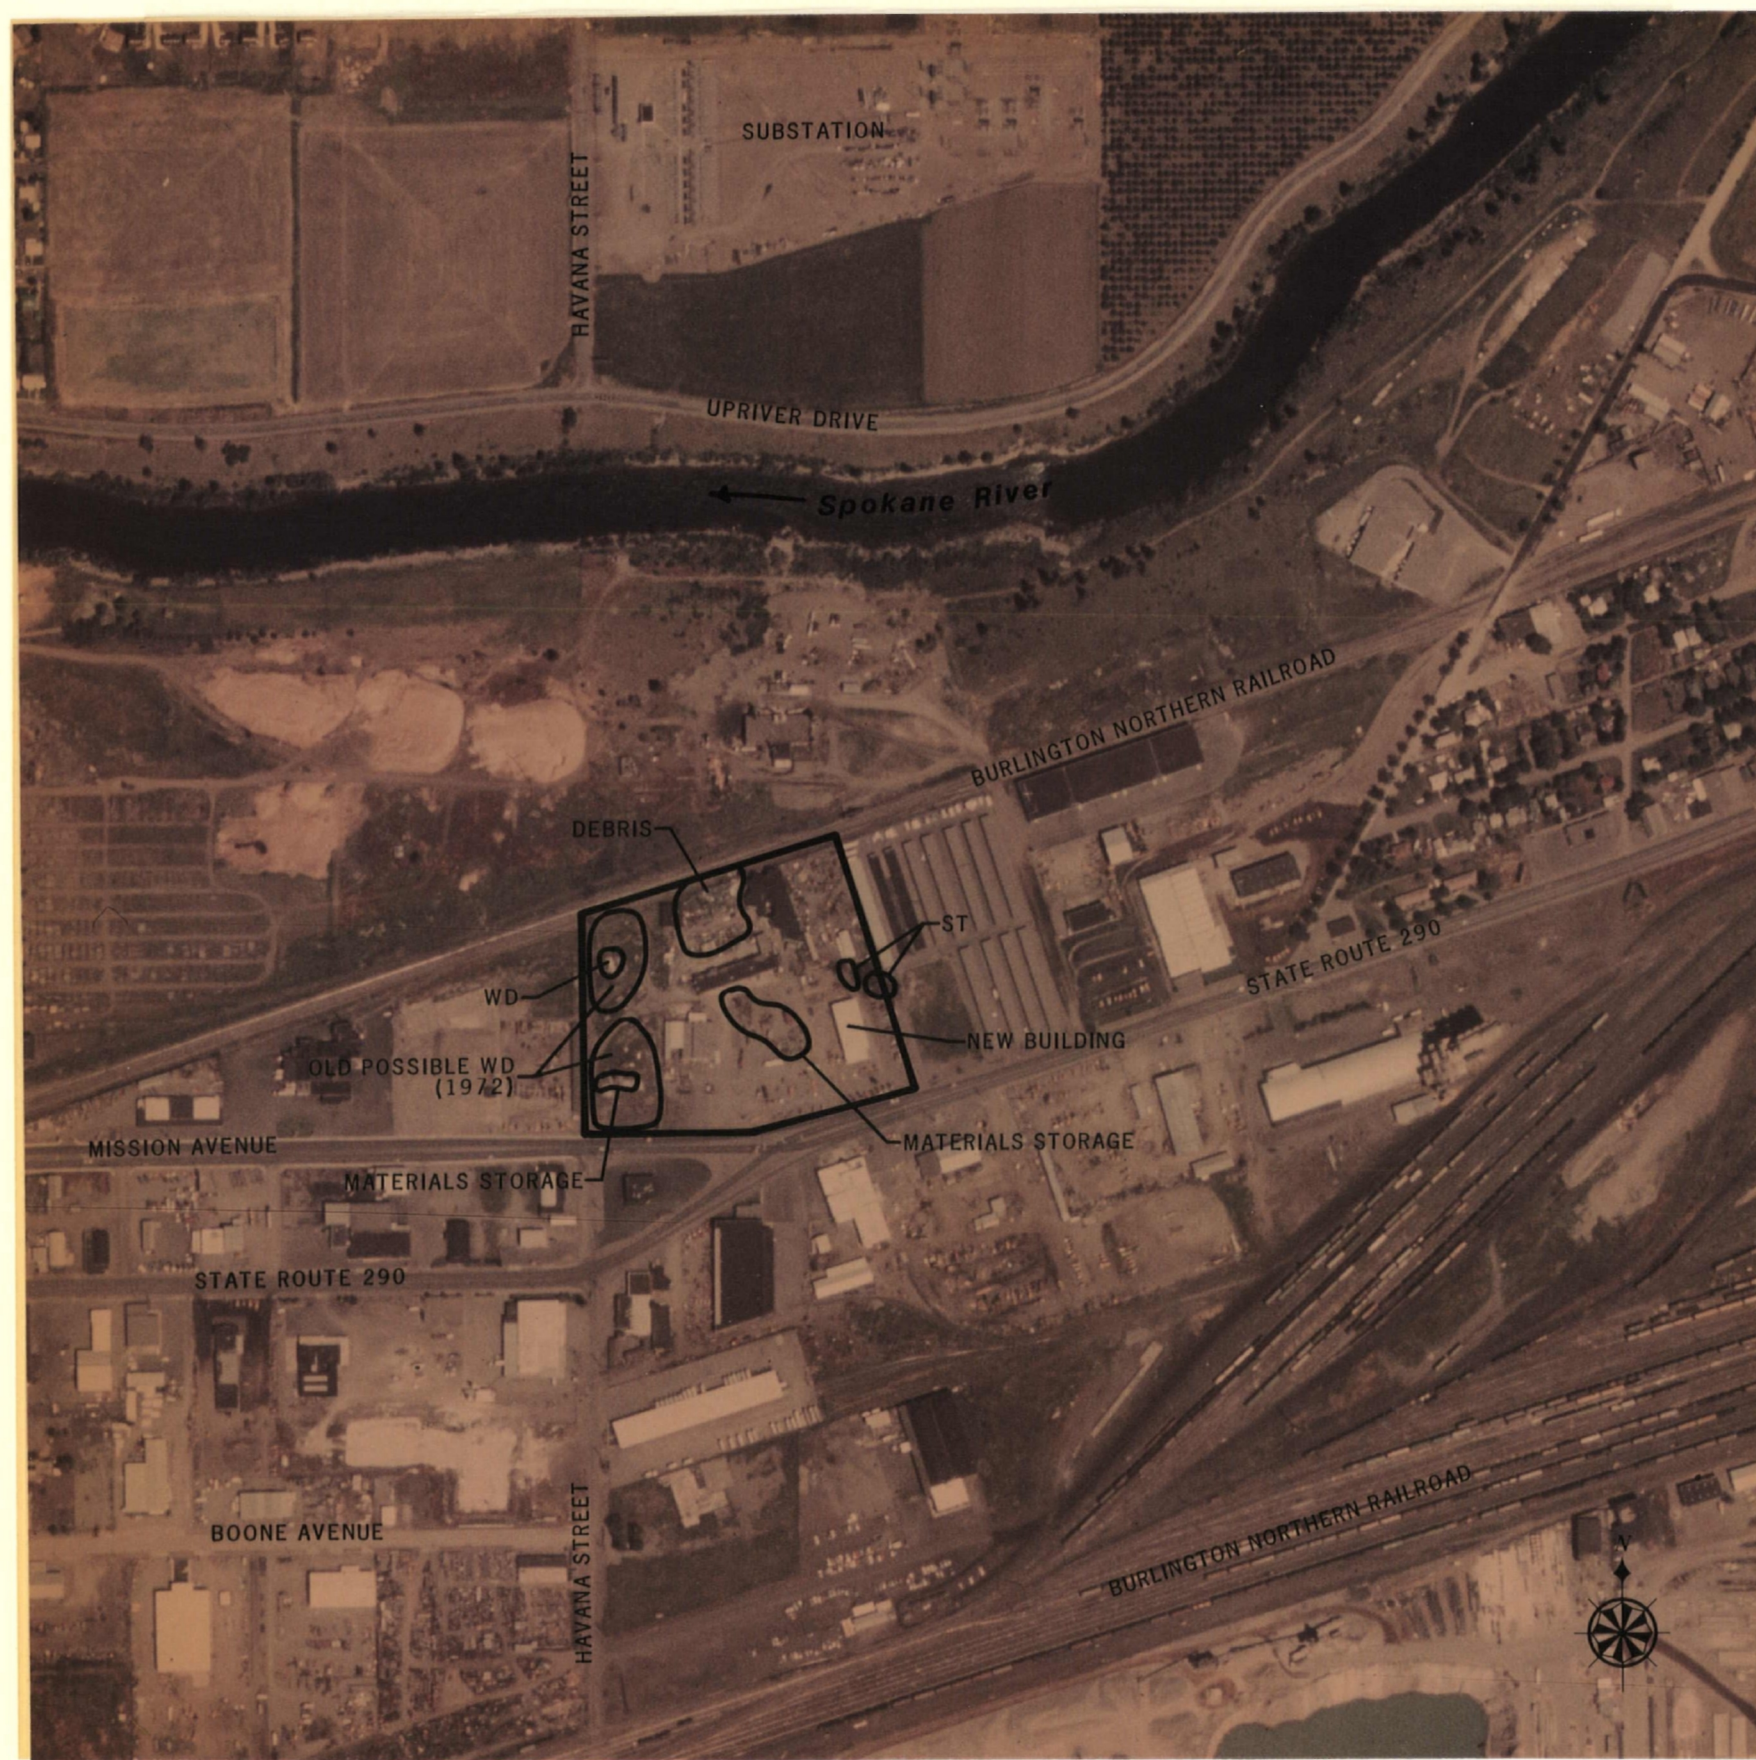
Figure 9. General Electric-Spokane Apparatus facility, June 18, 1978. Approximate scale 1:5,610.

JUNE 18, 1978 (FIGURE 9)

No substantial changes have occurred at the site since the 1977 photocoverage.
